Autonomous Soaring 2005 Flight Data Summary

Flight testing of the 14ft span CloudSwift UAV was conducted during the summer of 2005. Test maneuvers included aircraft checkout, Piccolo gain tuning, FTS range tests, and thermal soaring research flights. A description of each flight is given in table 1.

2006 Autonomous Soaring Project Flight Data Summary

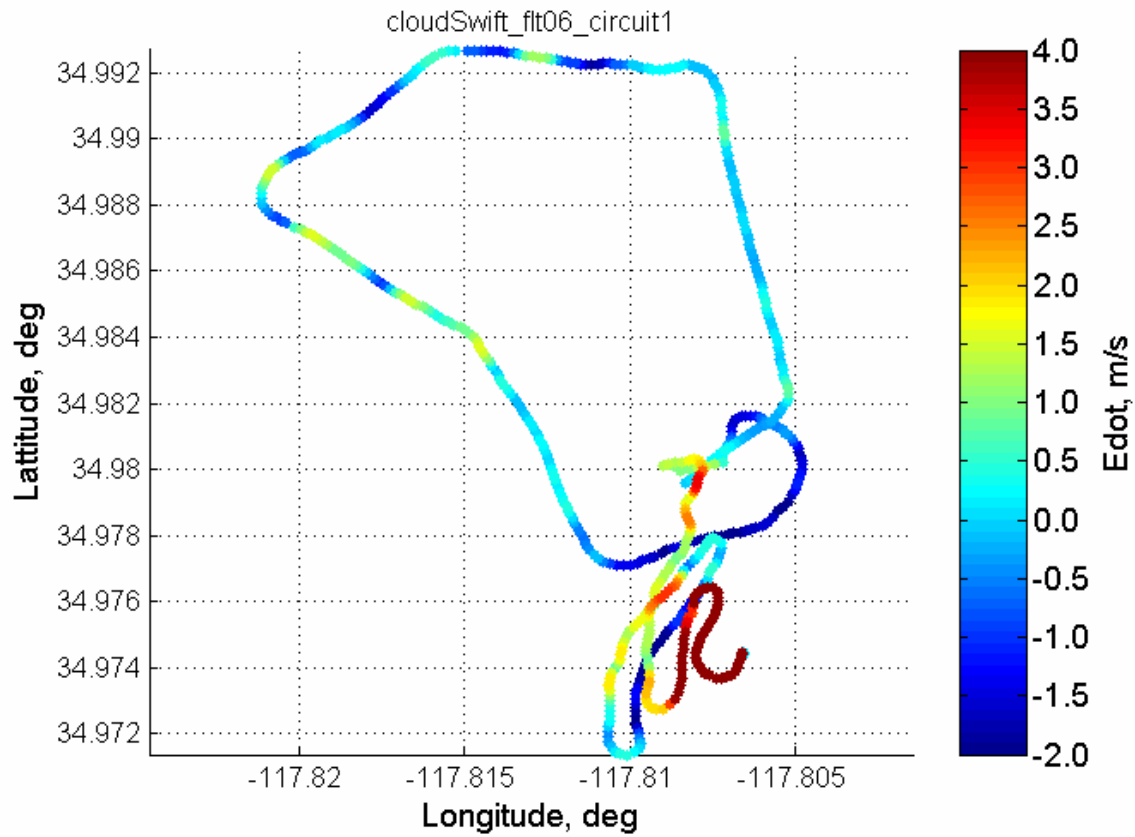
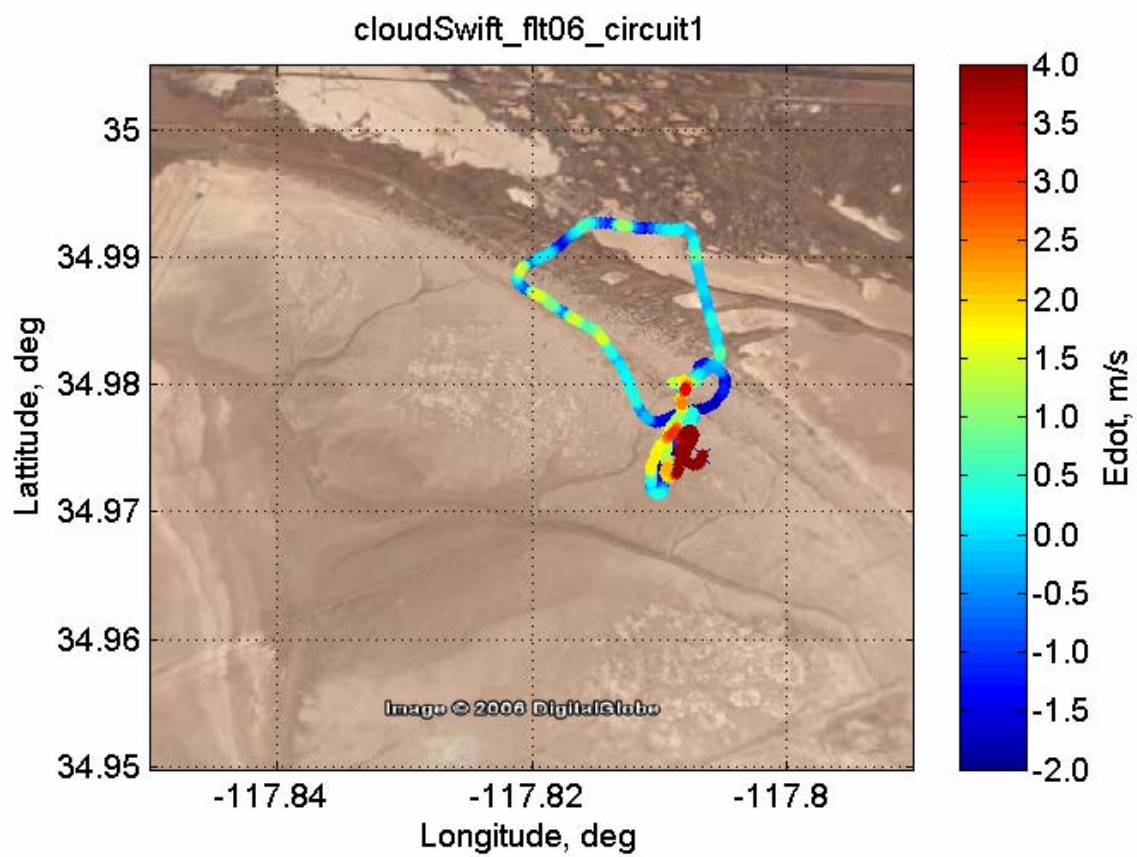
Flight 06, circuit 1

Circuit 1 is the first circuit around the flight path during flight 6. Takeoff and initial climb to altitude is included here in red. No significant thermals were encountered during this circuit. Poor altitude tracking is noted.

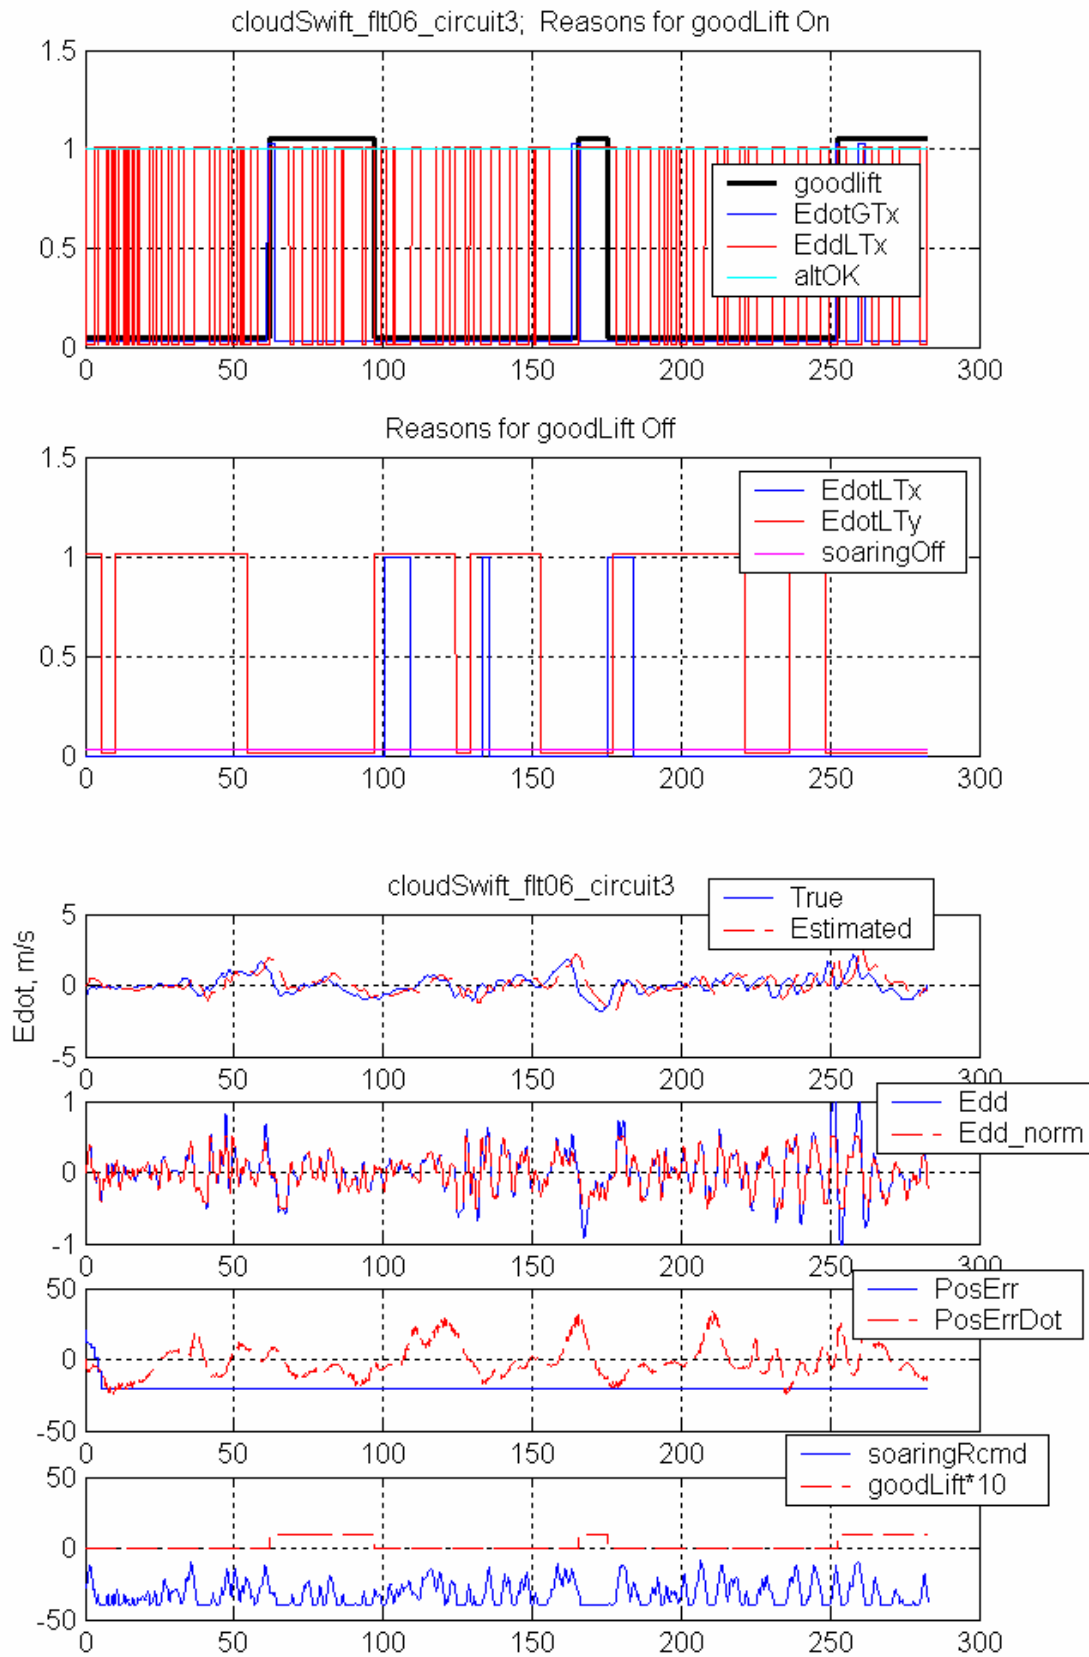
Flight 6, circuit 3

Three thermals were encountered during this circuit. Note the irregular structure of the thermals and the presence of downdrafts before and after the thermals.

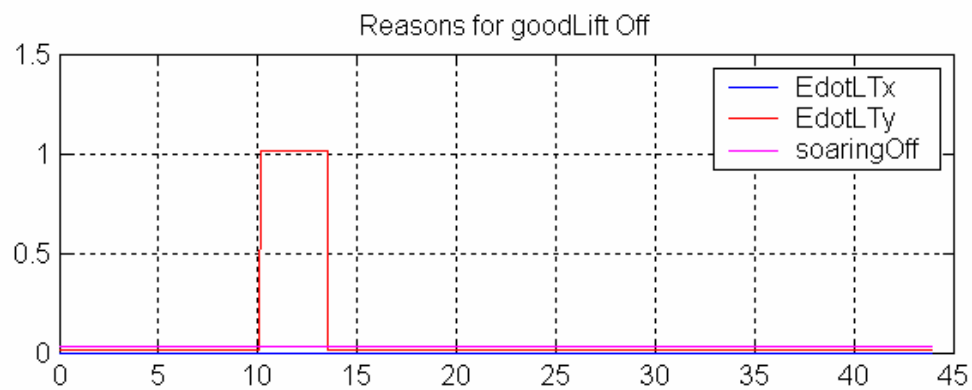
Flight 6, updraft 11

A strong updraft with a double peak shape. Note the false change in pitch angle.

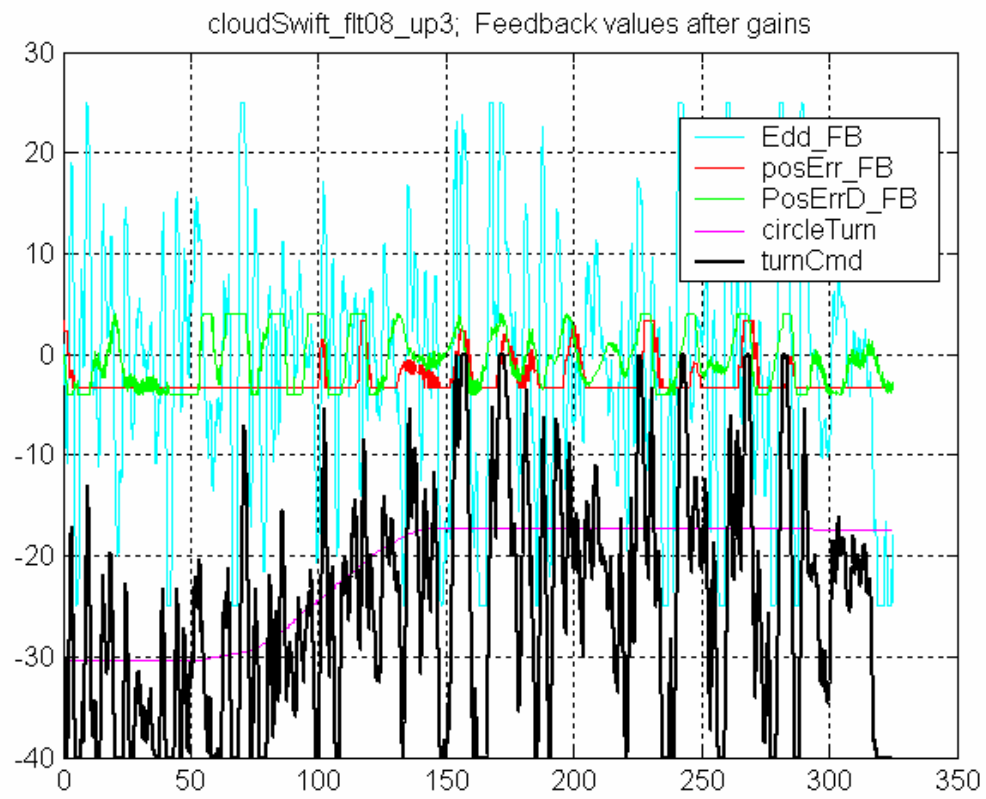
Flight 8, updraft 3

Long duration, better lift at end, fits thermal shape well, dH=1300'

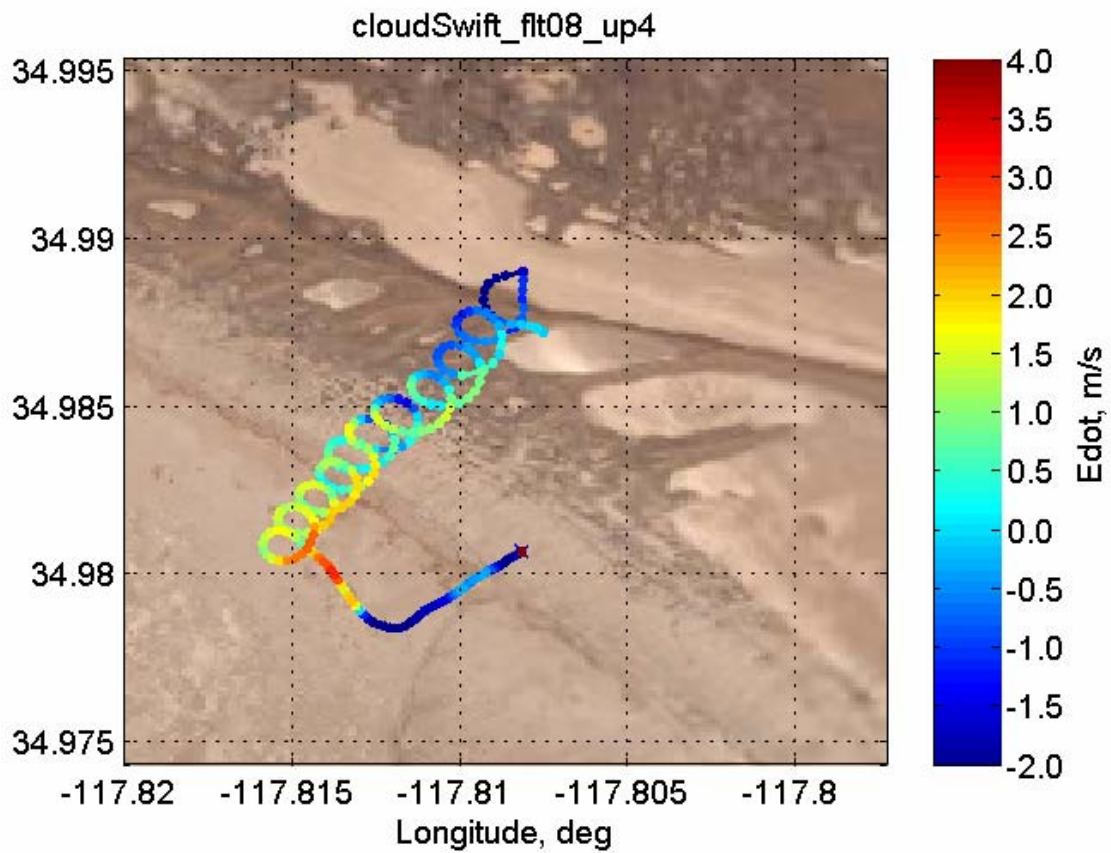
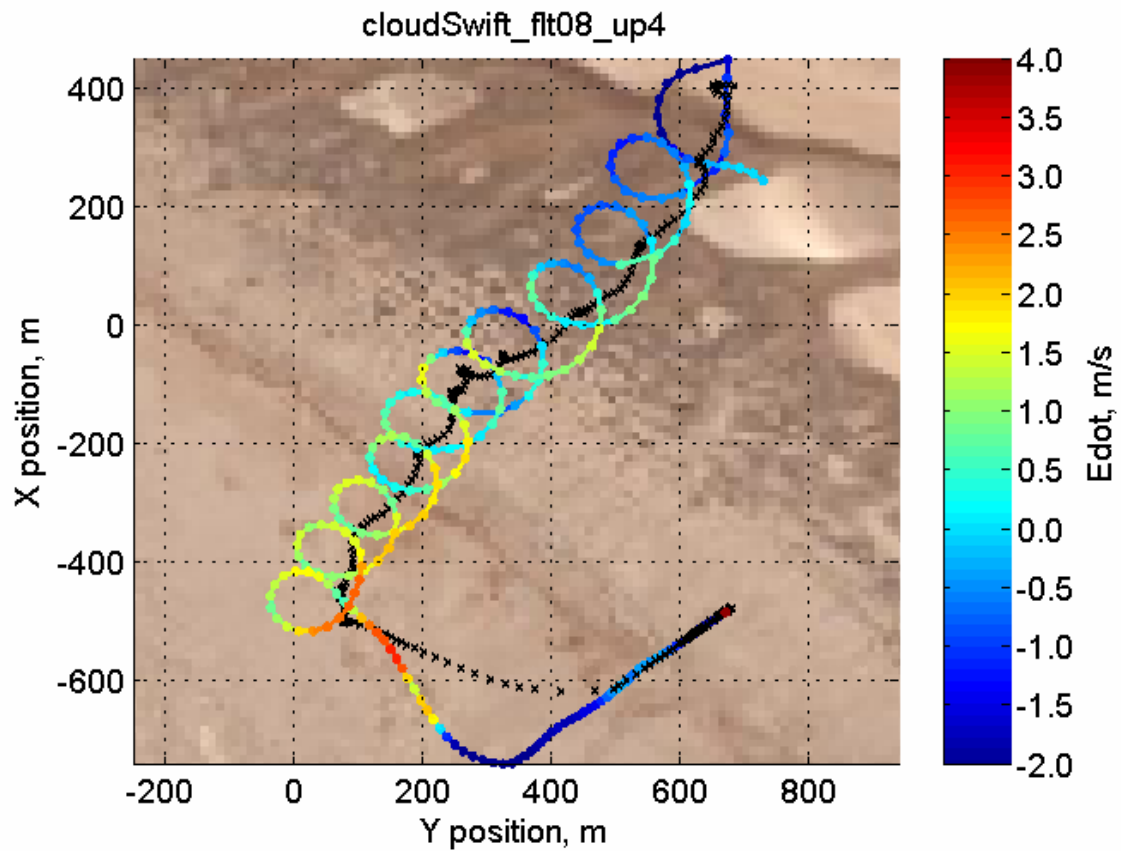
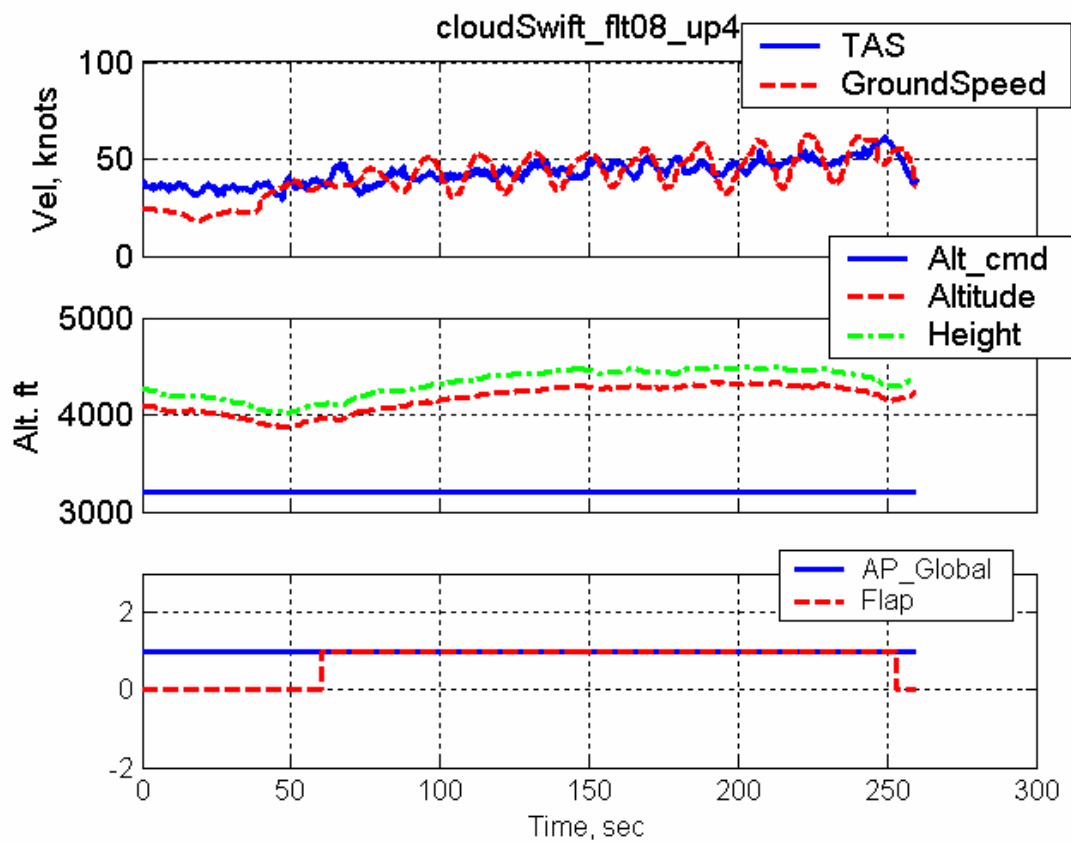
Flight 8, updraft 4

Nice climb in moderate strength thermal. Delays in Edd cause centering to be slightly off.

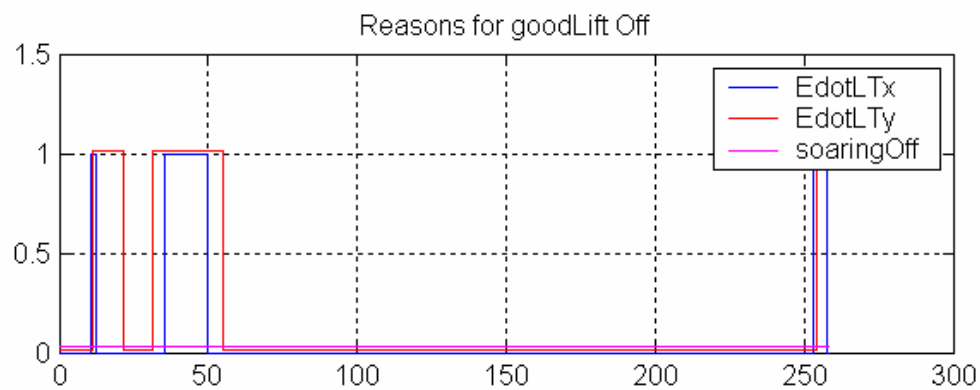
Flight 8, updraft 5

Thermal stops drifting. Also may have had gps sat changes.

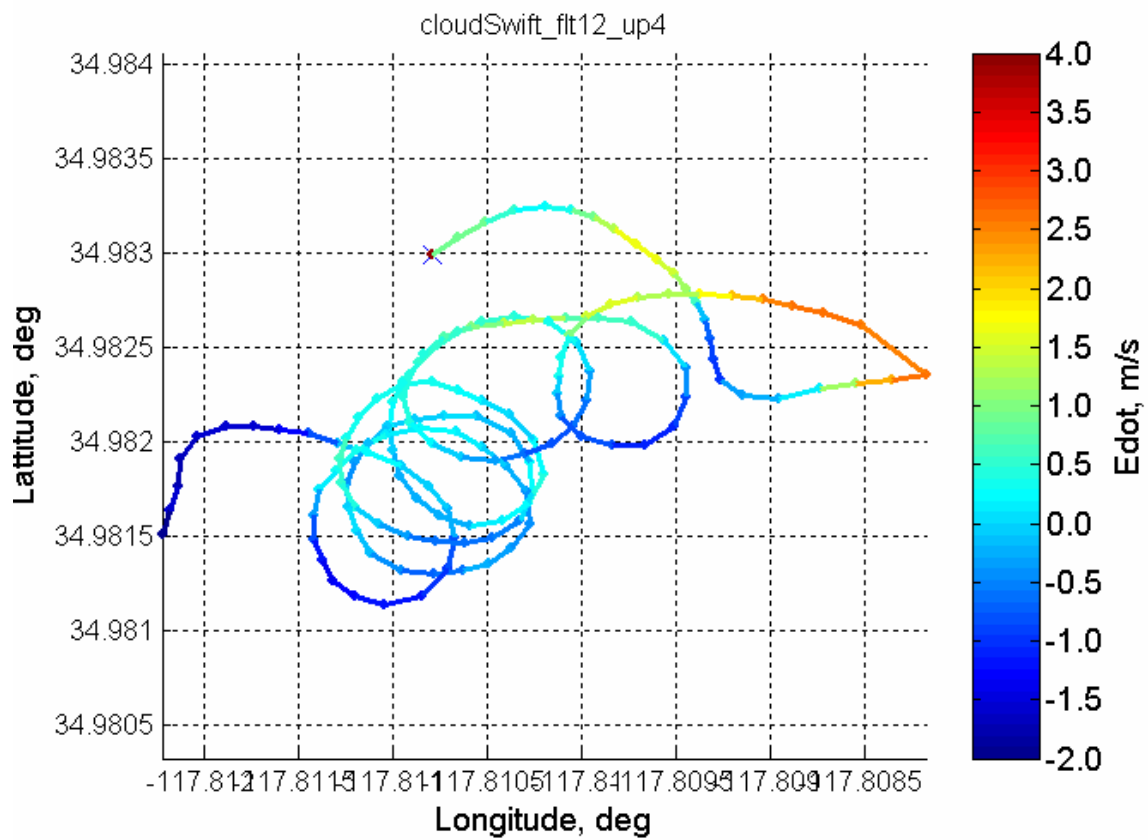
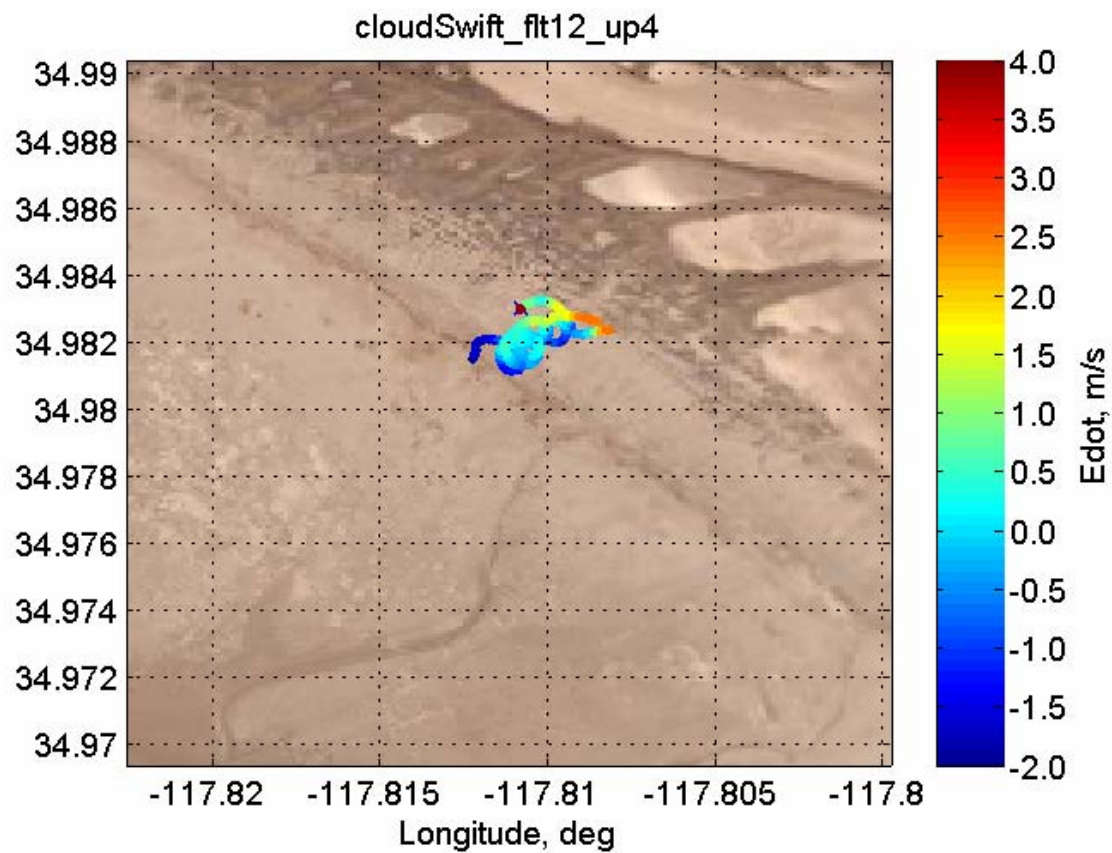
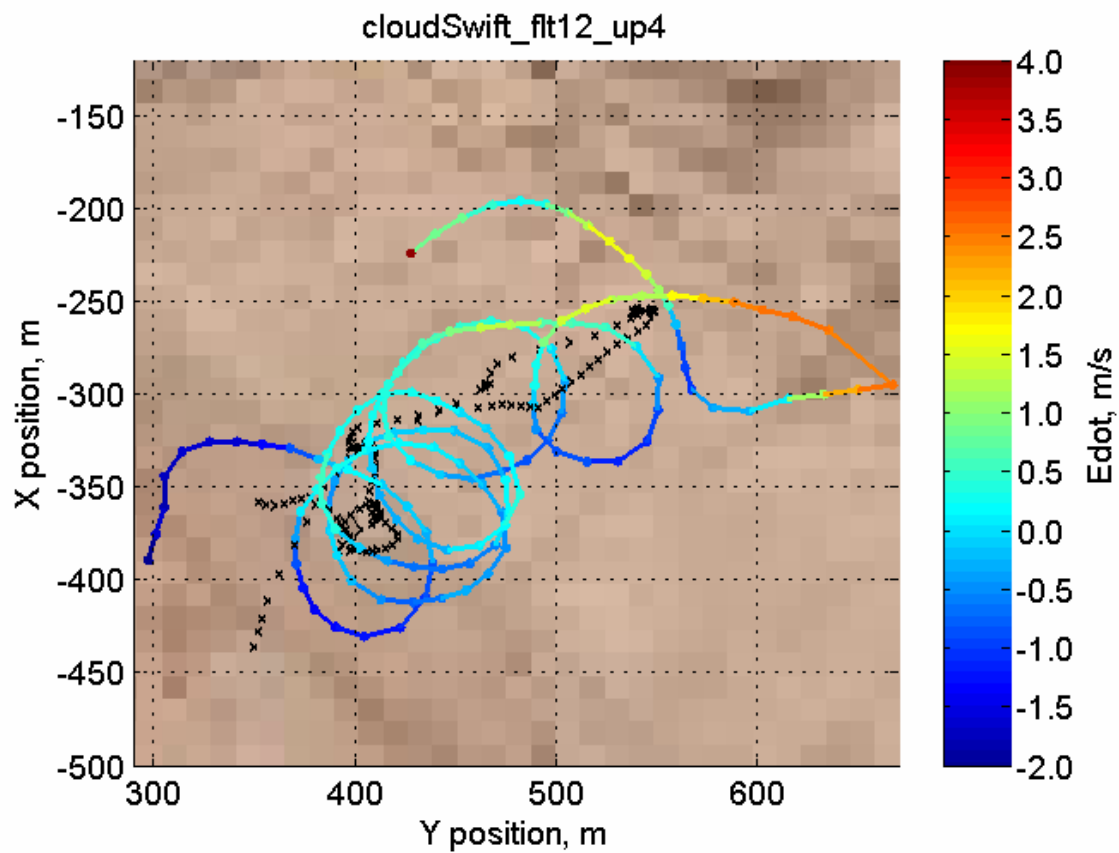
Flight 12, updraft 4

GPS problem caused aircraft to fly out of lift. The aircraft never got back into the good lift.

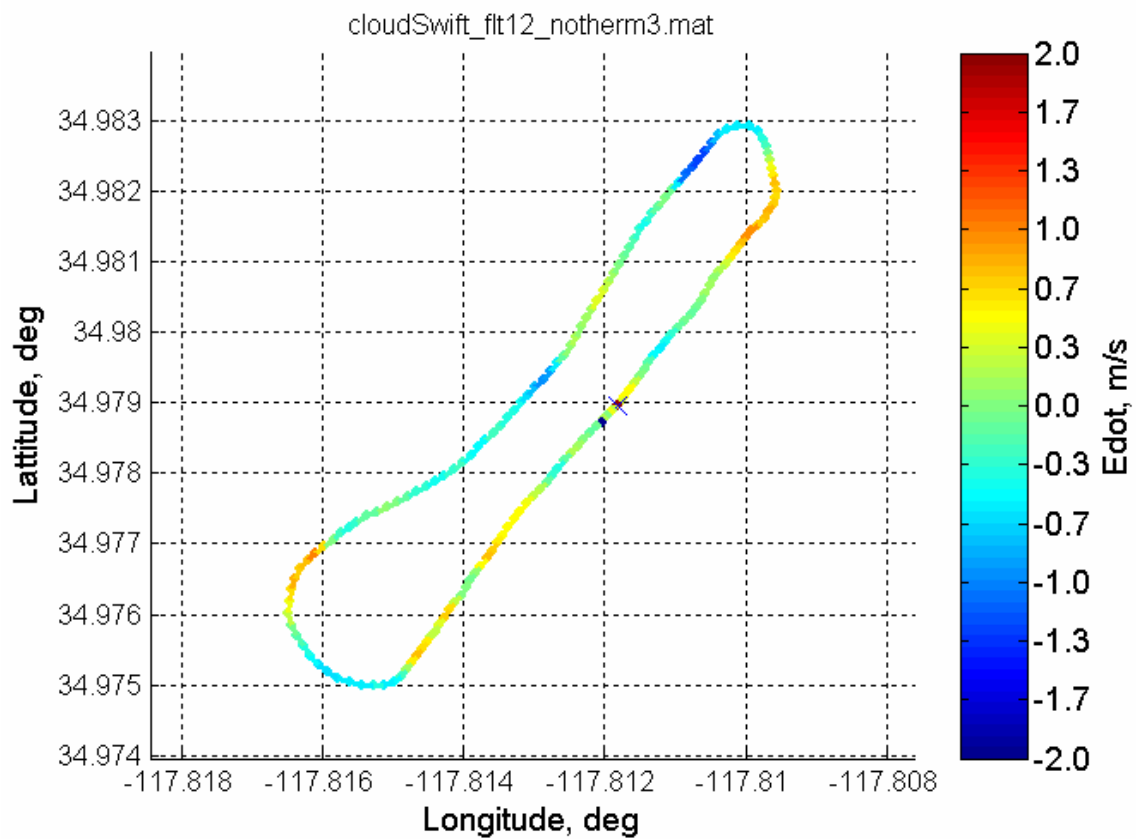
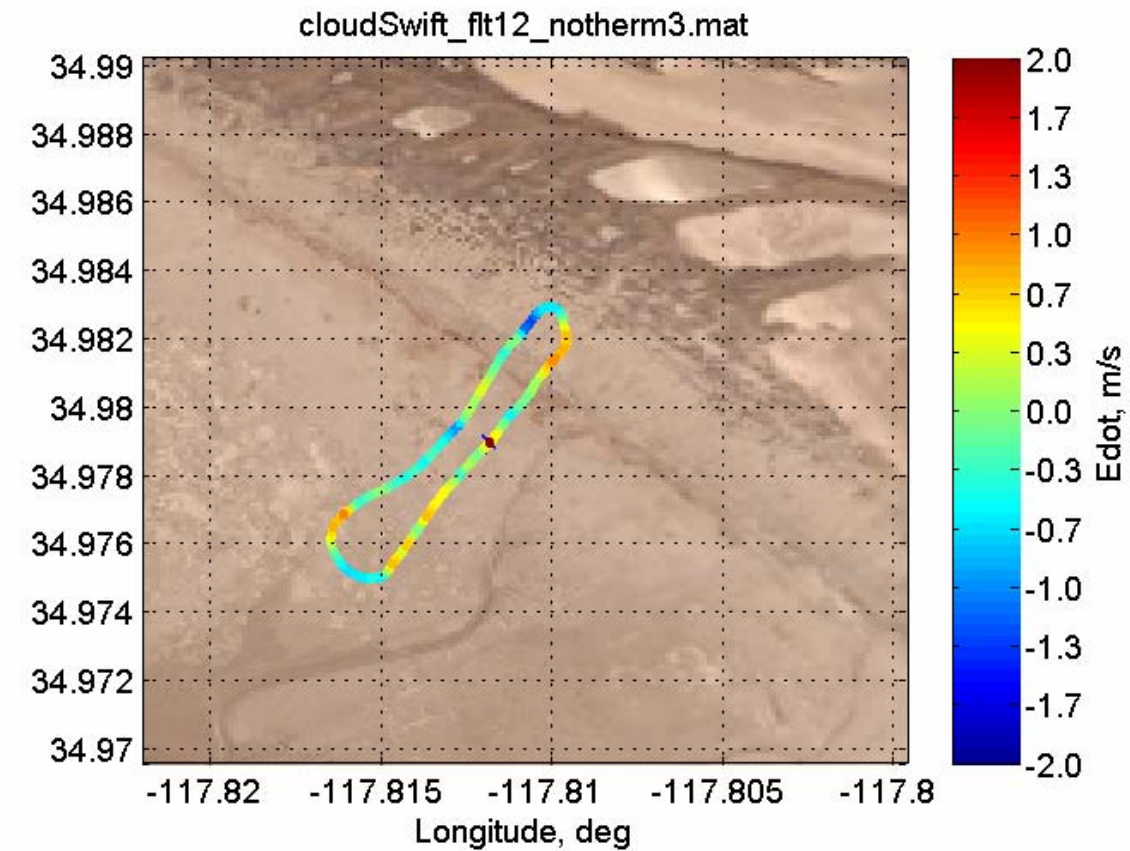
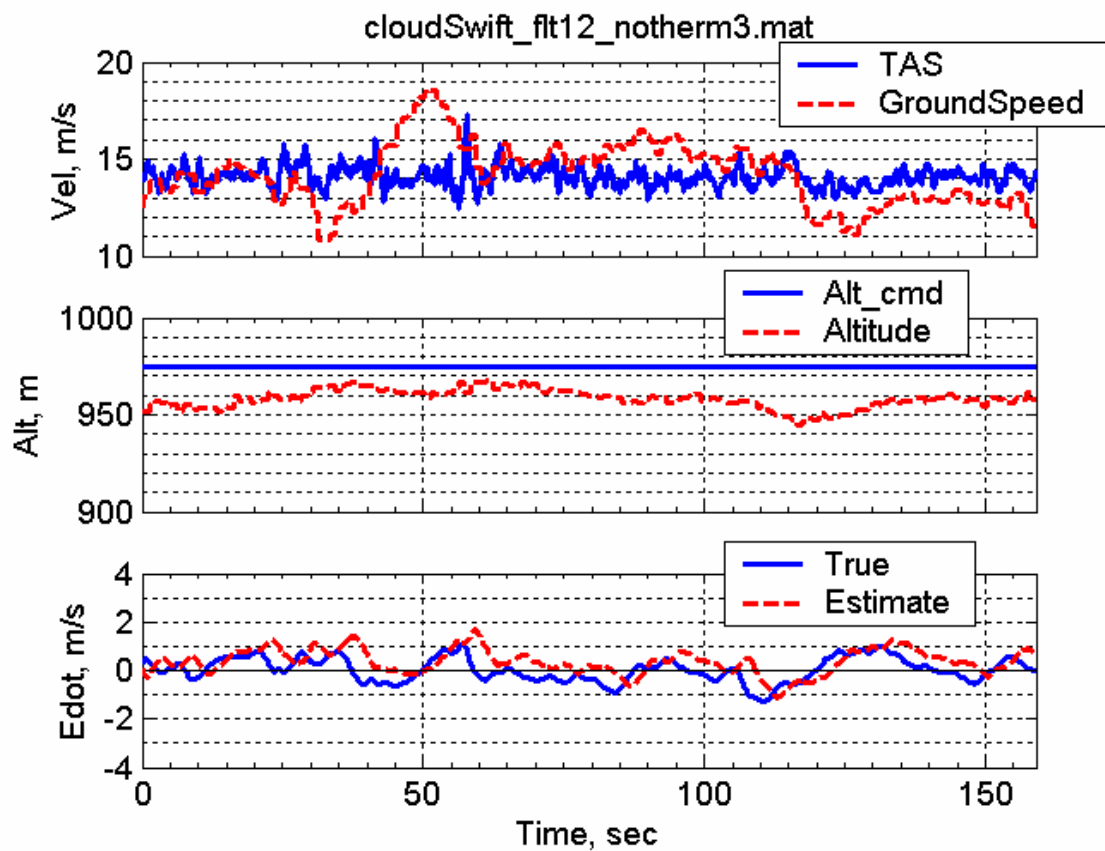
Flight 12, no thermals 3

Nearly big enough lift. Wind causes large difference in vel & groundspeed. Smarter soaring algorithms would stop and investigate this thermal before moving on.

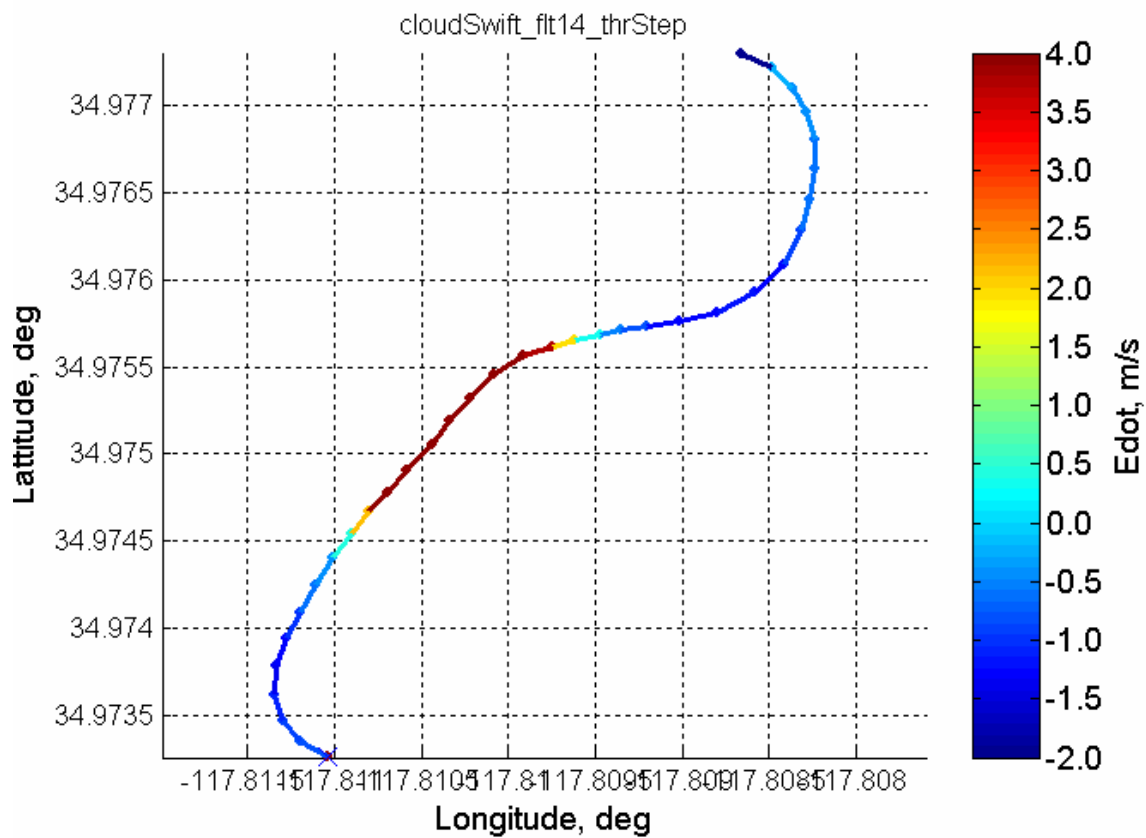
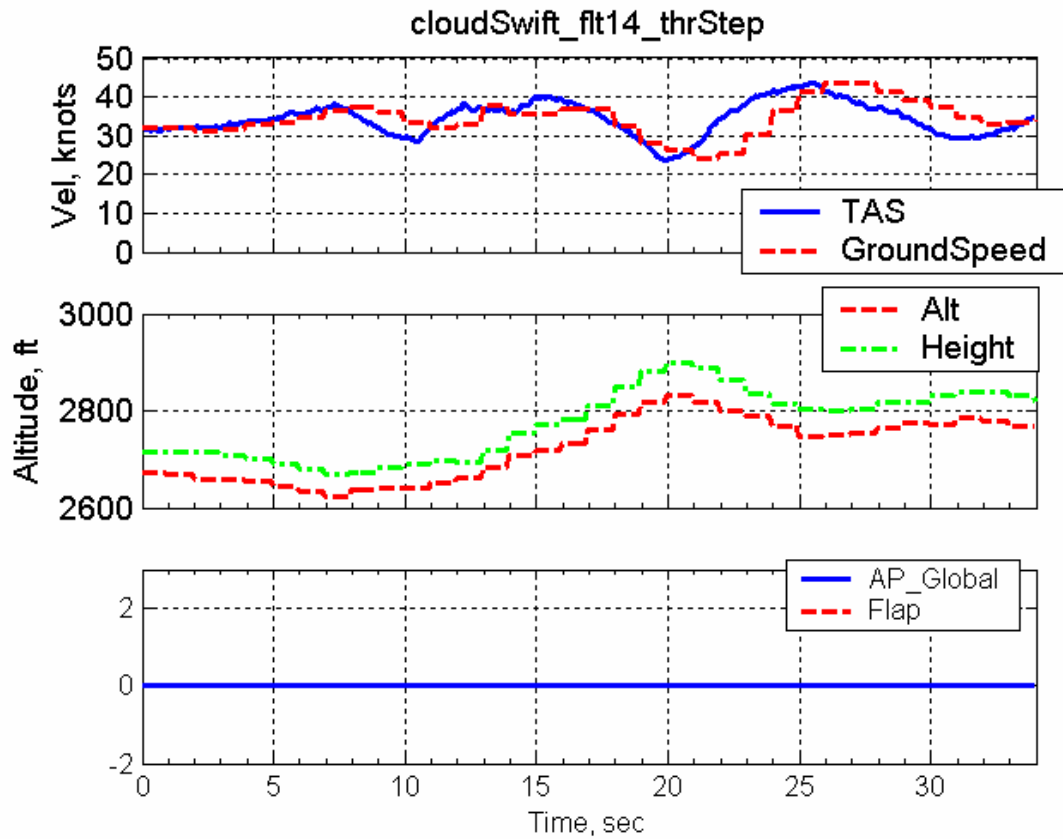
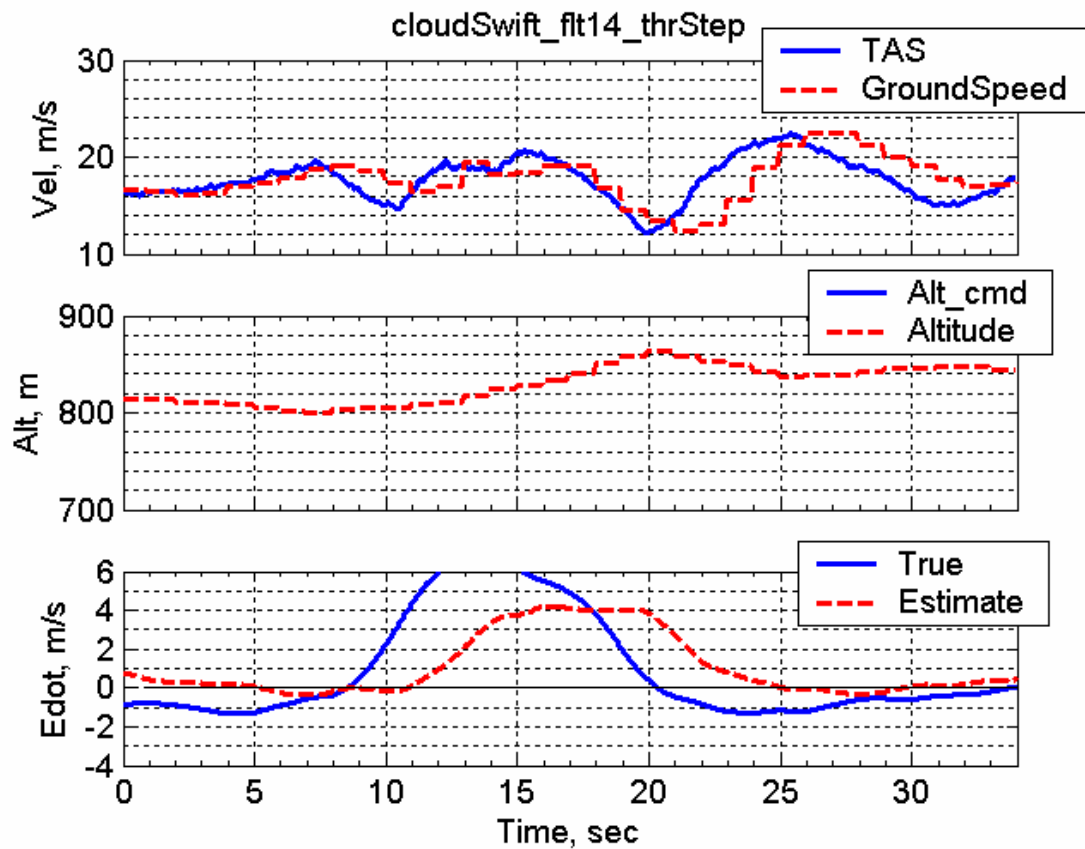
Flight 14, Throttle Step

Estimated Edot should remain around zero because engine effects are removed. The engine model found in the edot estimation blocks needs to be tuned with more data. The throttle vs. edot curve is likely nonlinear.

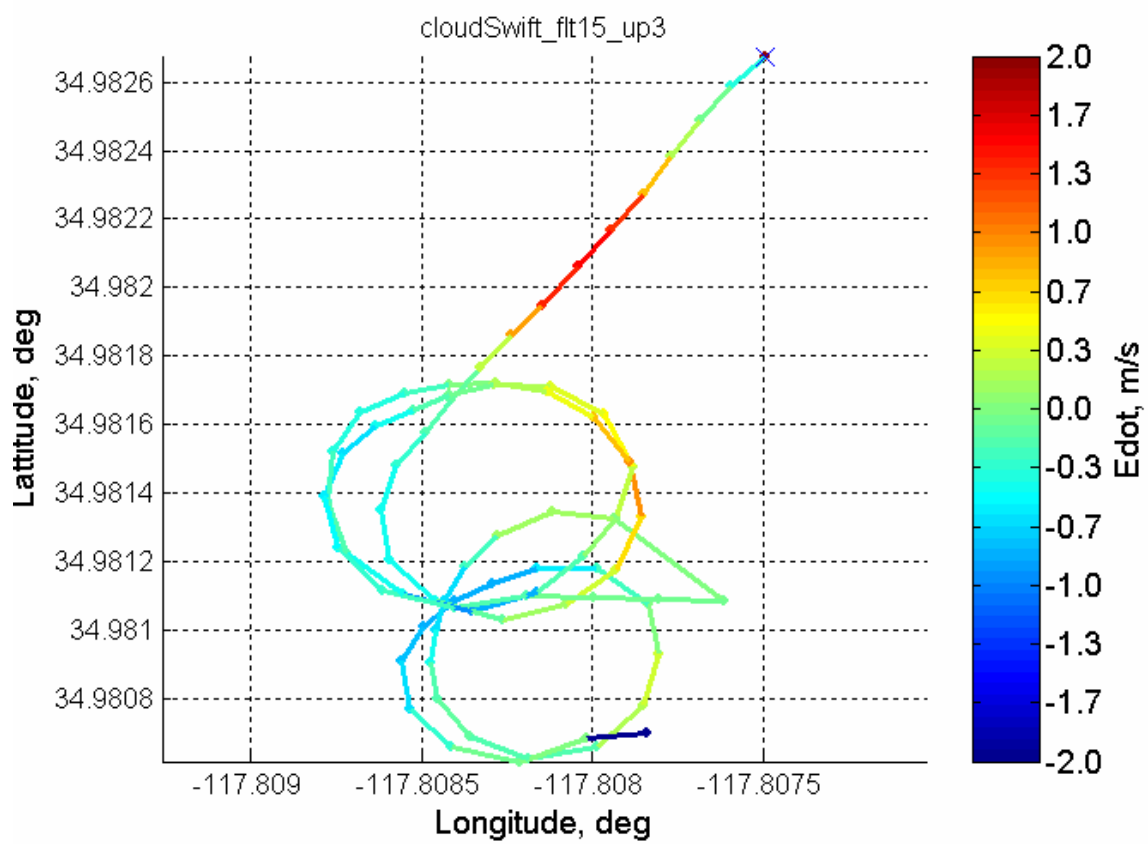
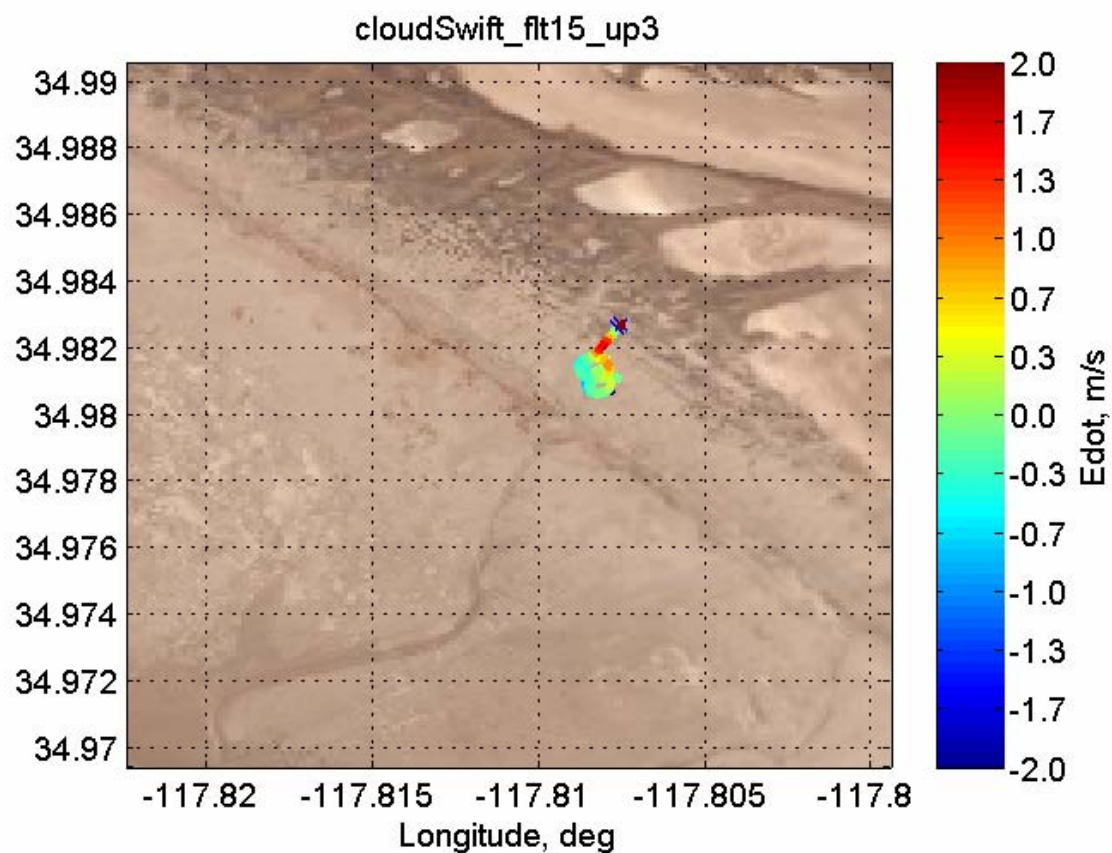
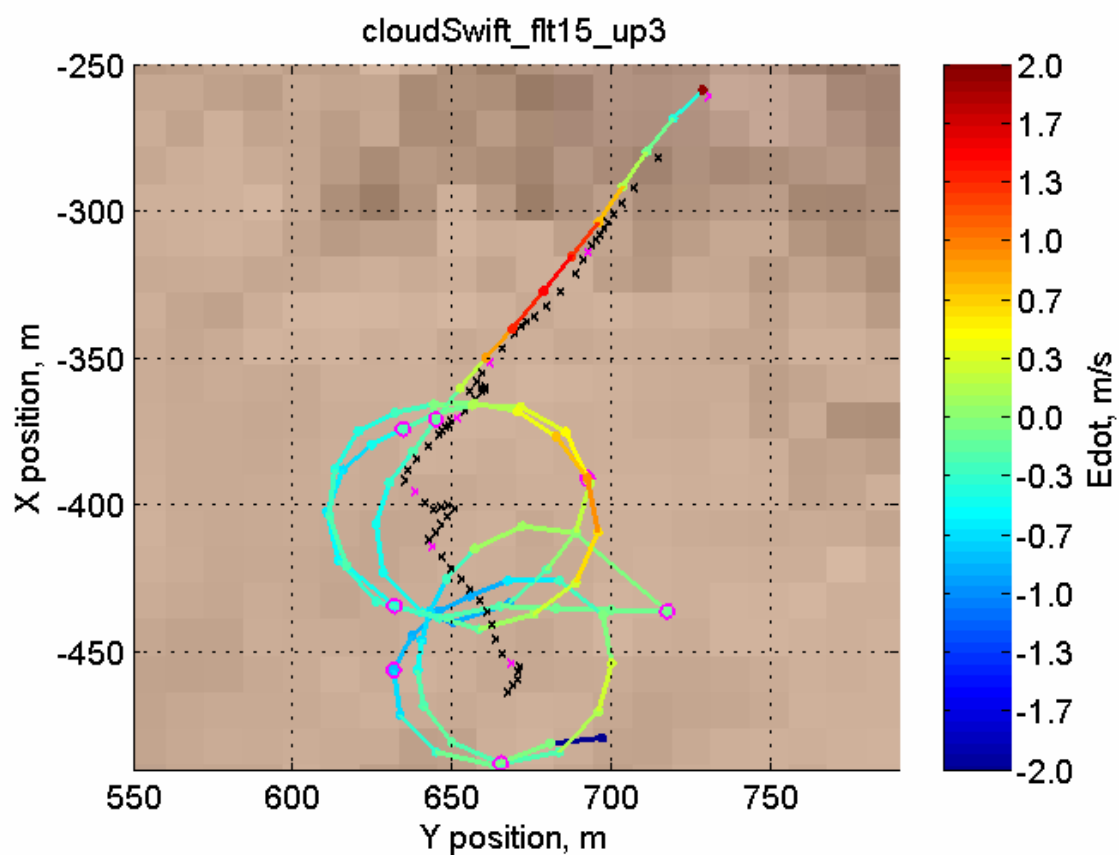
Flight 15, updraft 3

Aircraft did not center thermal well. Estimator seems to be working. posErr and Edd delay caused poor centering.

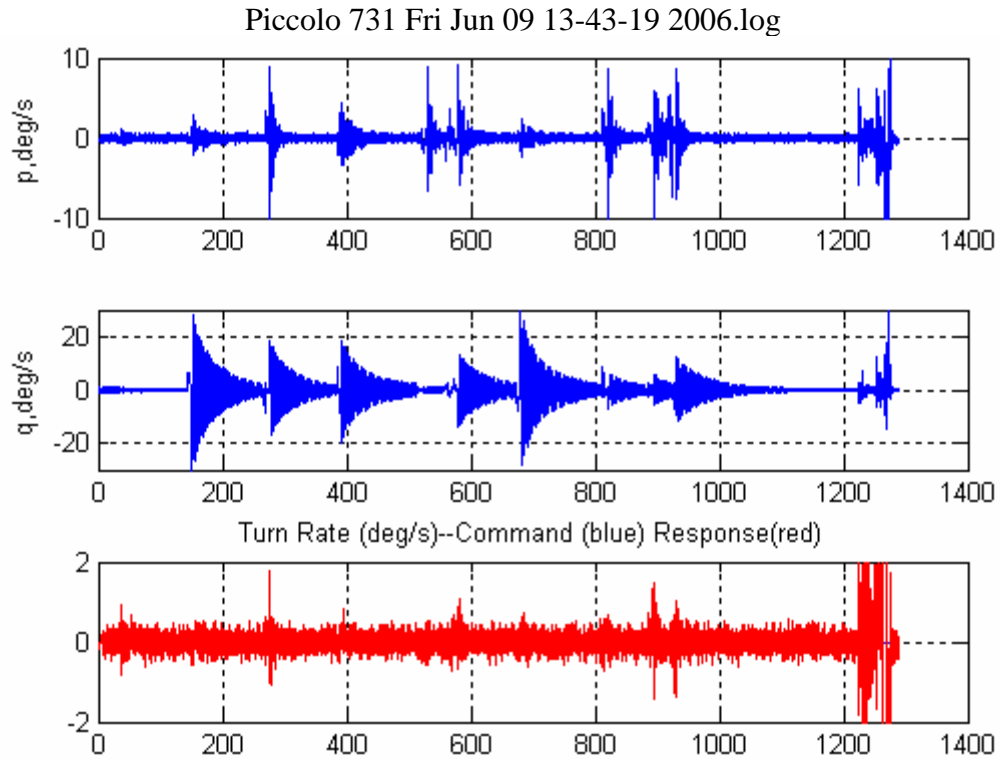
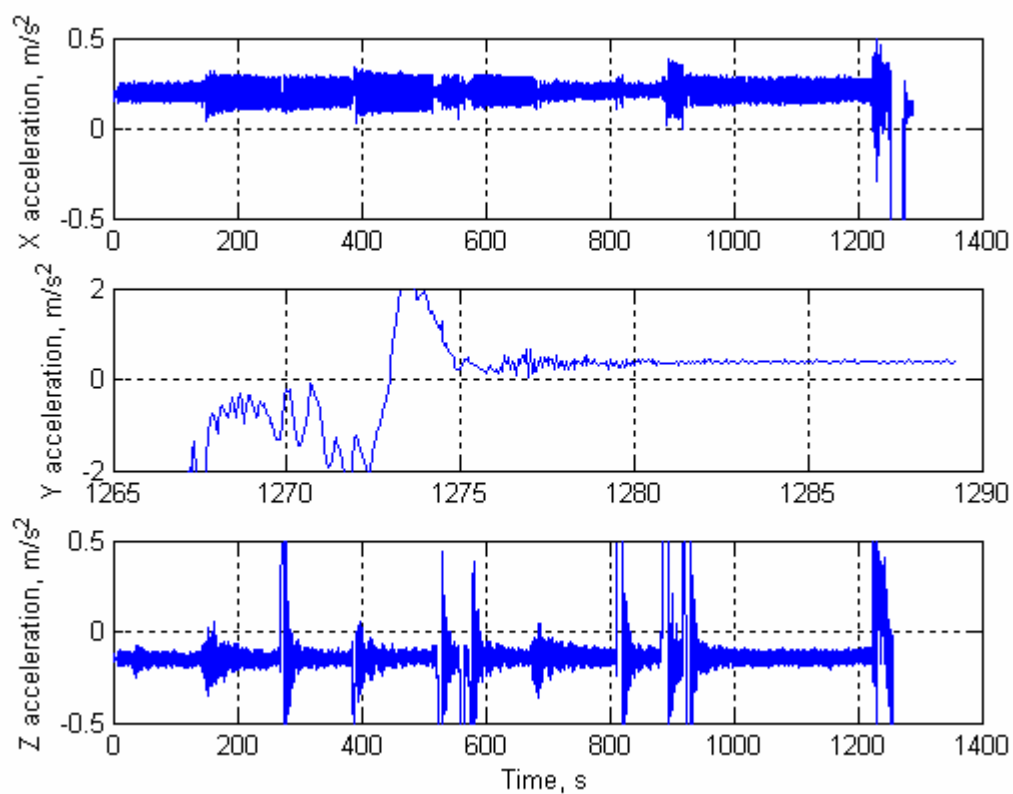
- Suspension length = 98.5"
- Horizontal spacing = 23.0"
- Mass = 10552.4g

Pitch inertia of the aircraft and box was found to be $1.21 \pm .01$ slug-ft²

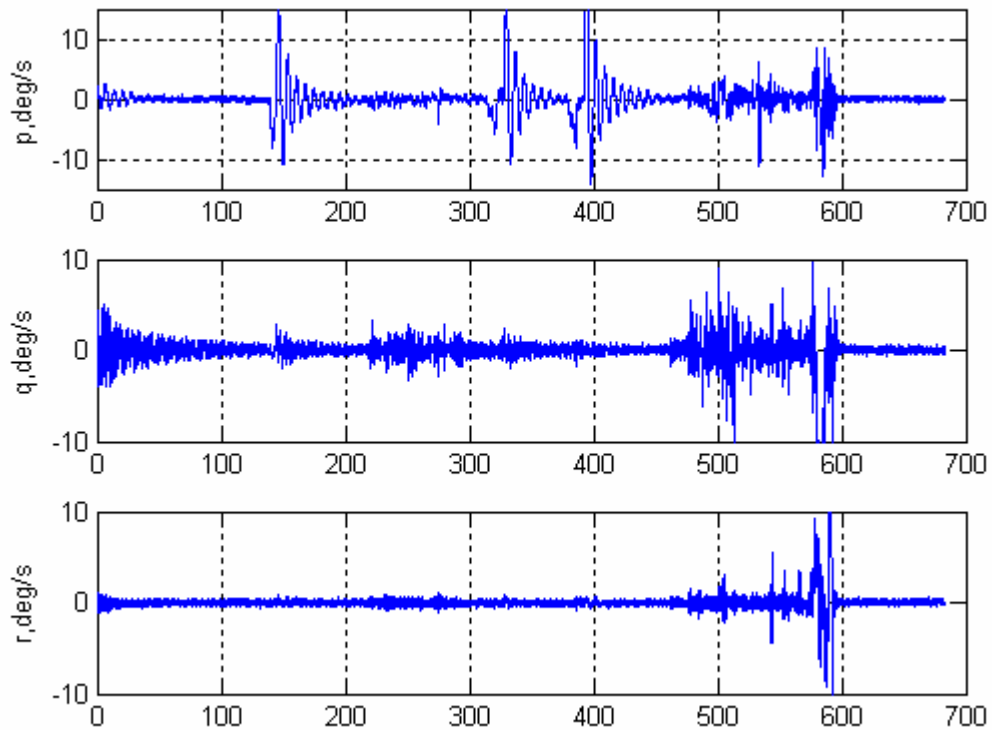
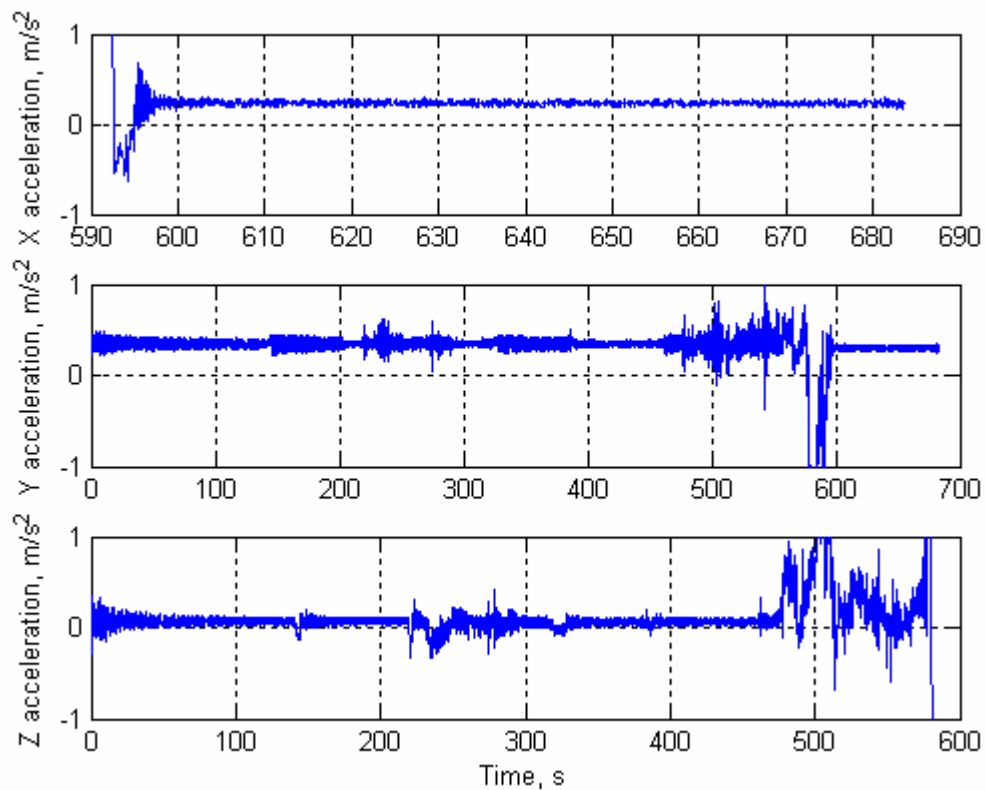
1.1.3 Roll Swing

Roll swing data was taken with the following configuration:

Roll inertia of the aircraft and box was found to be $2.055 \pm .045$ slug-ft²
